Safety Notice

Application of radiography to measure the remaining wall thickness of external corrosion

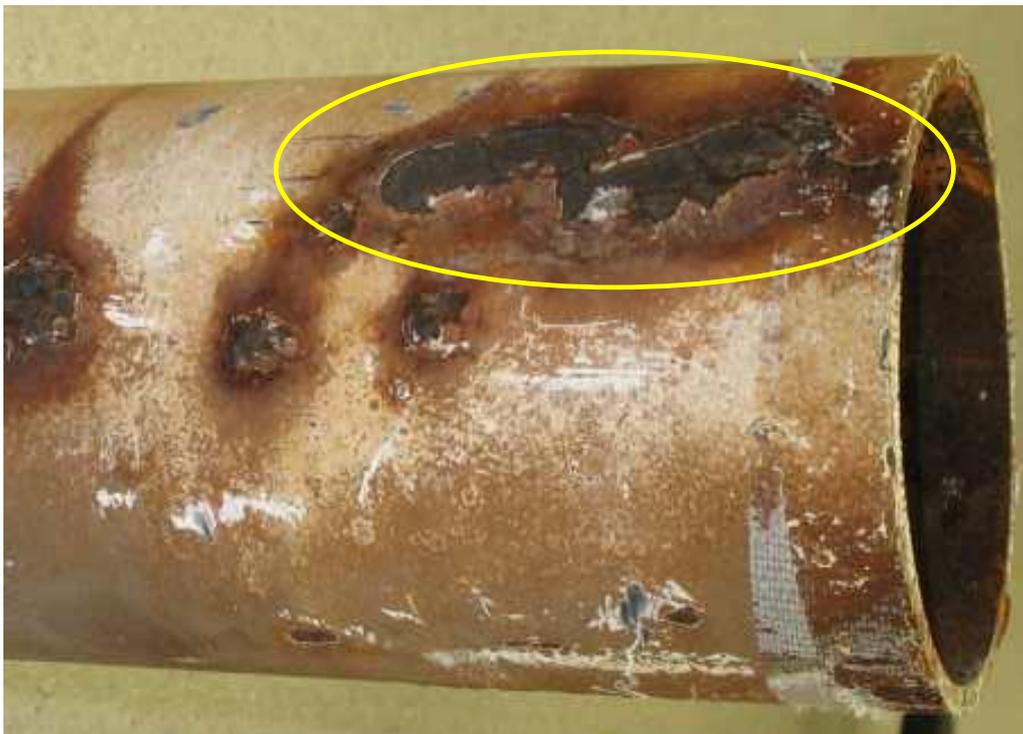
For an ex-service 6" schedule 40 pipe with a 6mm high external corrosion scab (see Figure 2), it was found that a series of exposures needed to be taken with an angular increment of 5° or less around the tangent position to find the deepest point on the corroded area, which extended over about 30° of the circumference. At the thinnest point, the interpretation of the corresponding digital radiograph was complicated by the presence of features within the pipe wall. If these were ignored, the remaining ligament measured from the radiograph was 3.4mm, which was 1.5mm larger than the accurate value of 1.9mm derived by precision internal ultrasonic inspection. Alternative interpretations, using the internal features within the pipe wall gave values closer to the actual value on this image but on others, at different angles, the remaining ligament measured in this way was less than the actual value.

Figure 2. Corrosion scab under sized by ~1.5mm using tangential radiography

The presence of structure/features apparently within the pipe wall, on the radiographs from the localised scab shown in Figure 2, may provide a method for recognising when interpretation is difficult and under-sizing, using the apparent outer edge of the wall, can occur, but does not give more accurate values.

- If localised external corrosion is known to be present, extending over a small fraction of the pipe circumference, when performing tangential (profile) radiography, care must be taken in aligning the source and detector such that the tangent position is as close as possible to the centre of the corroded area or the highest point of the scab (i.e. the point of apparent greatest severity of the corrosion).

- Exposures at different angles are needed either side of the apparent position of greatest severity of the corroded area to find the point of maximum wall loss/minimum thickness. The angular increment for these radiographs depends on the pipe diameter and corrosion morphology/circumferential extent. Typical values may be as small as 5° for significant corrosion extending over only a small fraction of the circumference of a 6" OD pipe, and 10-15° for more extended corrosion on small bore piping.

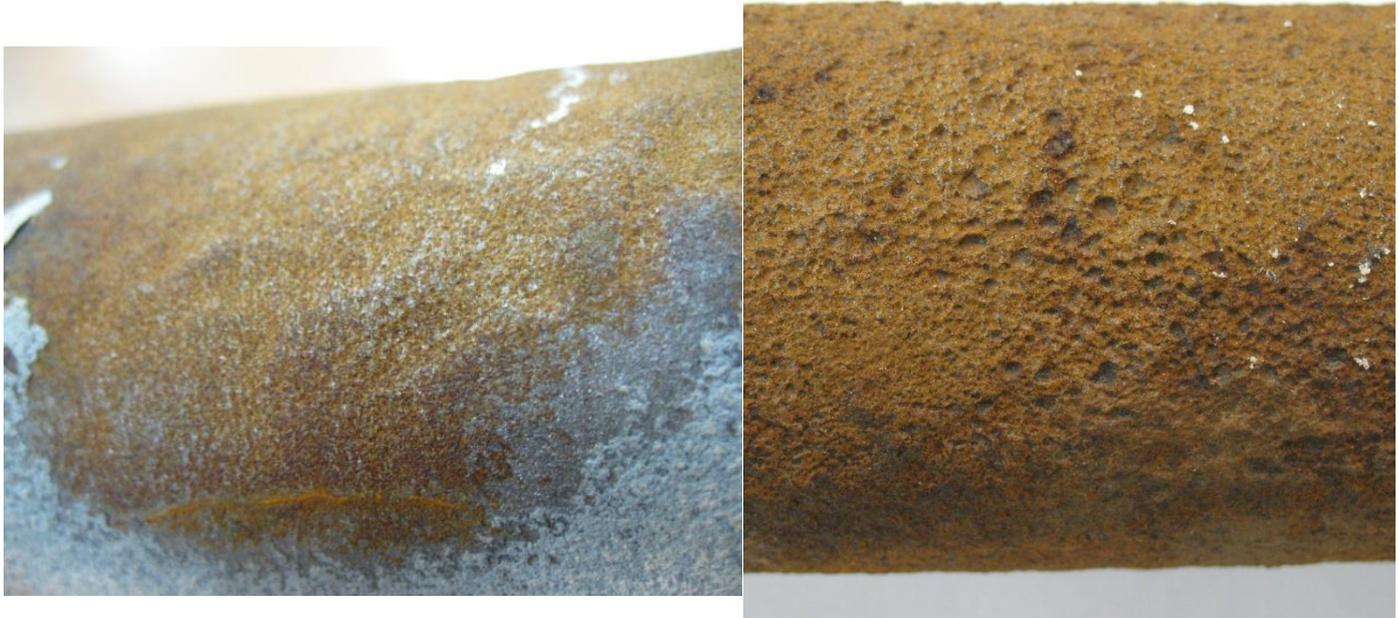
A number of similar looking externally corroded small bore (2") pipes were radiographed at 10° intervals and the minimum wall thickness was derived for each radiograph. Subsequently the corroded areas were blasted to remove the external corrosion product. It was only then found that the corrosion underneath the scabs was of two very different forms. For some of the pipes, the corrosion had left a gently undulating steel surface, Figure 3(a), whereas for others, a finely pitted steel surface was revealed by the blasting, with an almost honeycomb like appearance, Figure 3(b).

Figure 3. Two different forms of corrosion revealed after removal of the corrosion product (a) an even, undulating surface and (b) finely pitted surface.

Comparison of the radiography measurements of remaining wall thickness with benchmark values derived from the blasted pipes showed that for the finely pitted surface, the remaining wall thickness had been overestimated by up to 1.3mm, whereas for the more undulating surface much better agreement was found, to within ± 0.5 mm. Careful examination of the corresponding radiographs for the finely pitted pipes showed some evidence for the pitting in the double-wall double image (DWDI) region of the image, and in addition the OD profile was somewhat ragged or irregular, as illustrated in Figure 4.

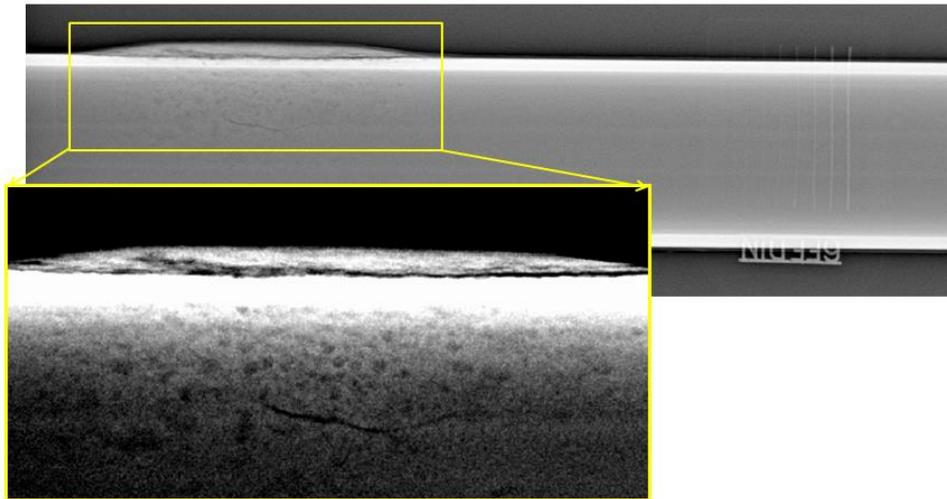
Figure 4. High pass filtered digital radiograph and magnified section with contrast settings optimised to show the fine pitting in the DWDI region of the image

However these features were not immediately apparent and required some optimisation of the image contrast and high pass filtering to show them clearly. Hence they could be missed unless specifically searched for by an experienced operator trained to look for them. Thus as with case study 1, careful examination of the radiographs can provide a method for recognising when under-sizing occurs, but does not, in itself, give more accurate values.

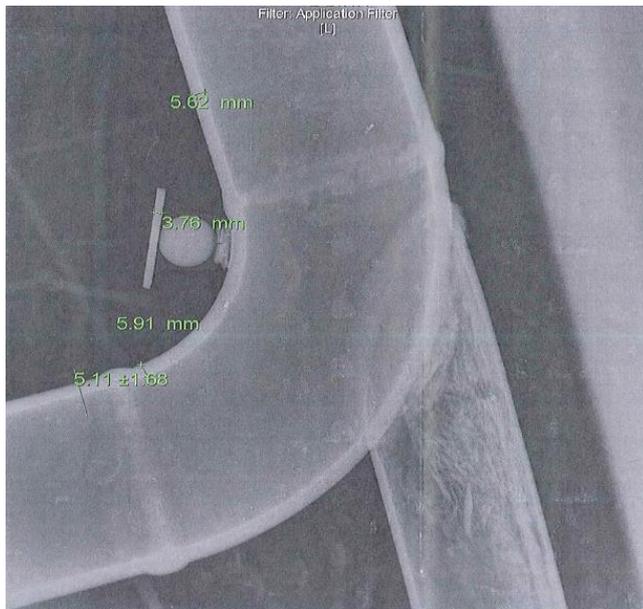
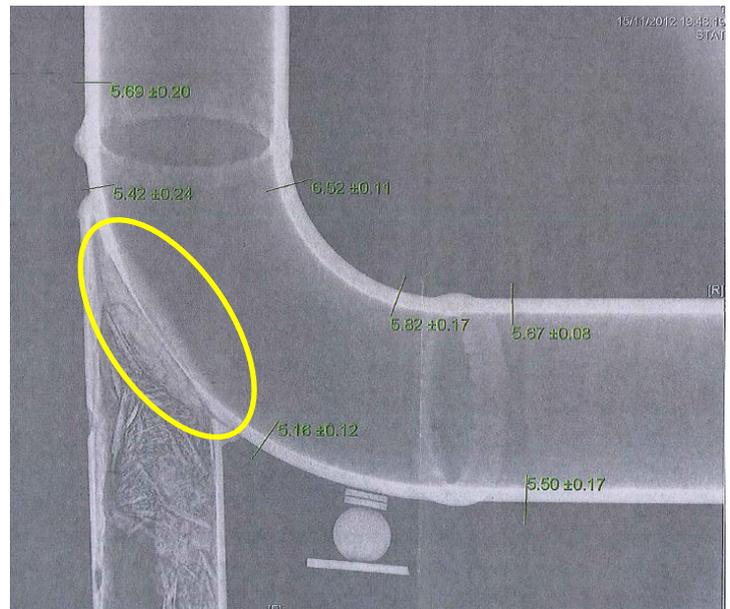
Figure 5 Computed Radiography (CR) images – original in-service image (left) and image with source and detector better aligned (right), following removal from service

In-service tangential computed radiography (CR) was performed on a trunnion support, but the area of external corrosion was not accurately aligned with the tangent position due to site constraints (adjacent pipework prevented the source and detector being positioned in the optimum locations). As a result, there were difficulties in the interpretation of the image, and no significant corrosion was reported from the CR image (see Figure 5 - left), but there was a known leak due to corrosion in the area. On Figure 5 (left) note that there is no sign of substantial wall loss. However, there are clues to the experienced operator that the image is misaligned and therefore unreliable for wall thickness measurement i.e. the edges of the pipe are not well delineated and the elliptical nature of the trunnion to pipe weld image.

This component was then cut-out and removed from service. Subsequent CR images were obtained with improved quality and without the site restrictions in the positioning of the source and detector, so that the corroded area could be better aligned with the tangent position. In addition, the source to detector distance was increased to reduce geometric unsharpness. This second CR image (see Figure 5 - right) clearly shows major corrosion, with a considerable section of the bend extrados having near zero apparent wall thickness.

Misaligned in-service CR image (no clear wall loss)

Better aligned CR image showing extensive external wall loss
